U.S. Department
of Transportation
Federal Aviation
Administration

Safety Alert for Operators

SAFO 18007
DATE: 6/1/2018

Subject: North Atlantic High Level Airspace (NAT HLA) Tracks at ½ Degree Latitude Separation, Resulting in Identical Avionics Waypoint Labels for Different Points 30 Nautical Miles (NM) Apart

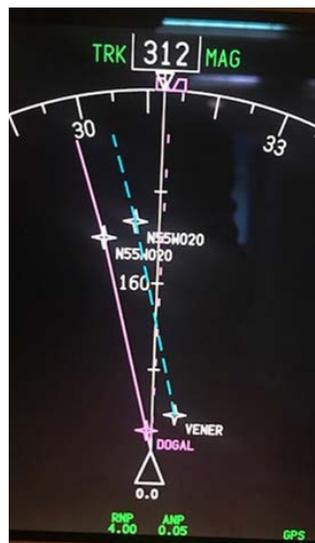
Background: Undesignated significant points are defined by geographic coordinates, and are being used on the NAT Performance-Based Communication and Surveillance (PBCS) tracks, which are spaced at one-half degree of latitude. Some navigation displays truncate (or, in some cases, round) manually entered or uplinked geographic coordinates to produce a 7-character waypoint label that uses only the degrees (not minutes) of latitude and longitude. With these displays, it is possible for different waypoints to be labeled the same. For example, the illustration below depicts two tracks on a navigation display. For the track shown in a solid line, the points DOGAL and N55°/W020° were entered. For the track shown in a dashed line, the points VENER and N55°30'/W020° were entered. Both tracks include the identical 7-character waypoint label, "N55W020," but are nominally separated by 30 NM.

Recommended Action: For operators with 7-character waypoint labels who fly in NAT airspace with unnamed points spaced at a half degree of latitude, the Federal Aviation Administration (FAA) recommends operators ensure their oceanic procedures are consistent with the Sample Oceanic Checklist found in Appendix D of [Advisory Circular 91-70B](#), *Oceanic and Remote Continental Operations* (revised in 2016). In addition, flightcrew training should be revised (as needed) to include specific reference to the potential of duplicate waypoint labels and the need to expand the waypoints to see degrees and minutes. More information can be found in the FAA NAT Resource Guide for United States Operators, at: https://www.faa.gov/about/office_org/headquarters_offices/avs/offices/afx/afs/afs400/afs470/media/NAT.pdf
